# Defluorinator / KOH Treater Corrosion

Frank Sapienza

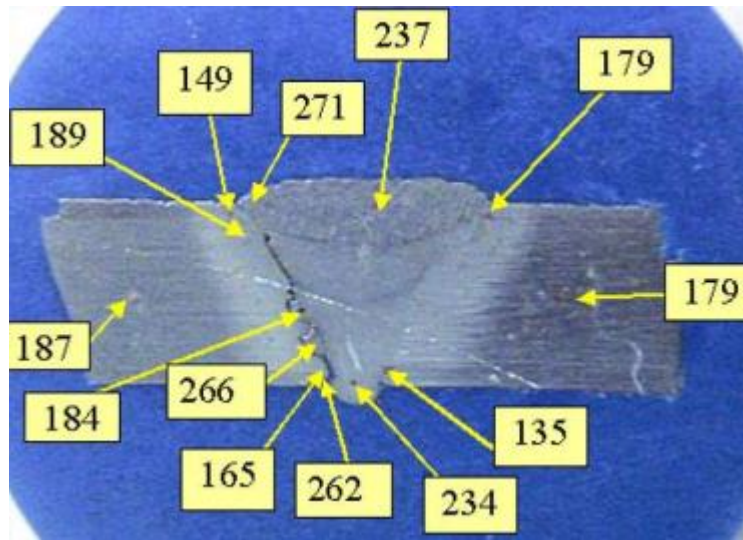
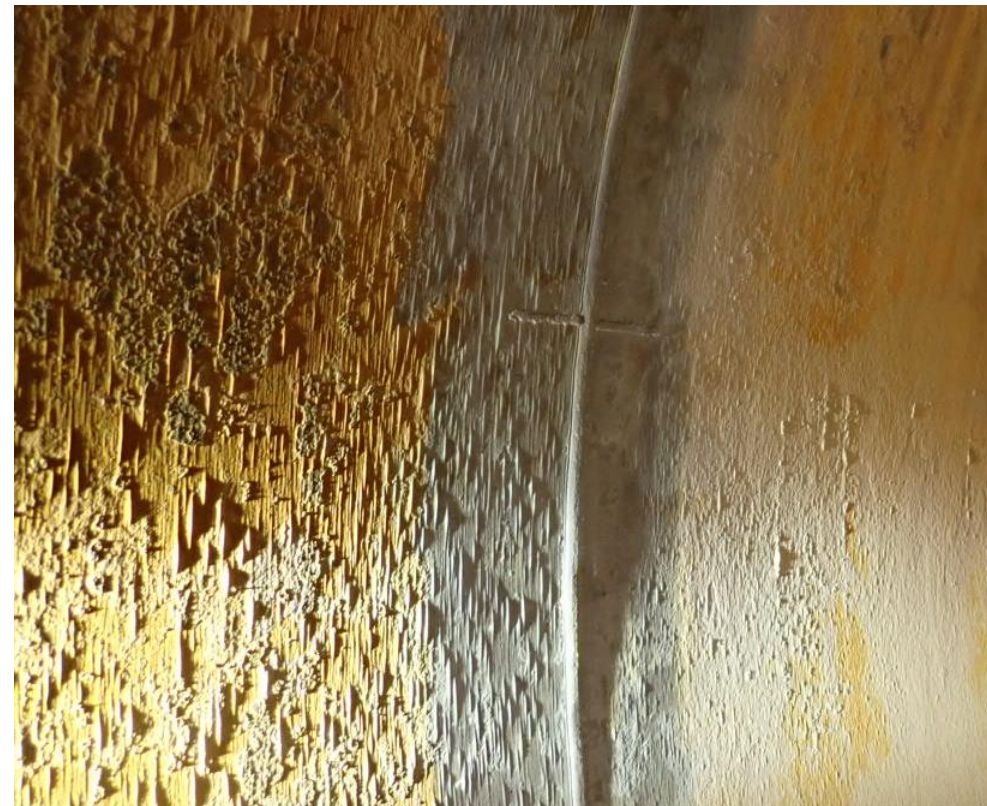
# Carbon Steel Environmental Cracking

- Base metal, weld deposits, and HAZ can all be susceptible
- Plate materials most susceptible
- Can be hardness driven

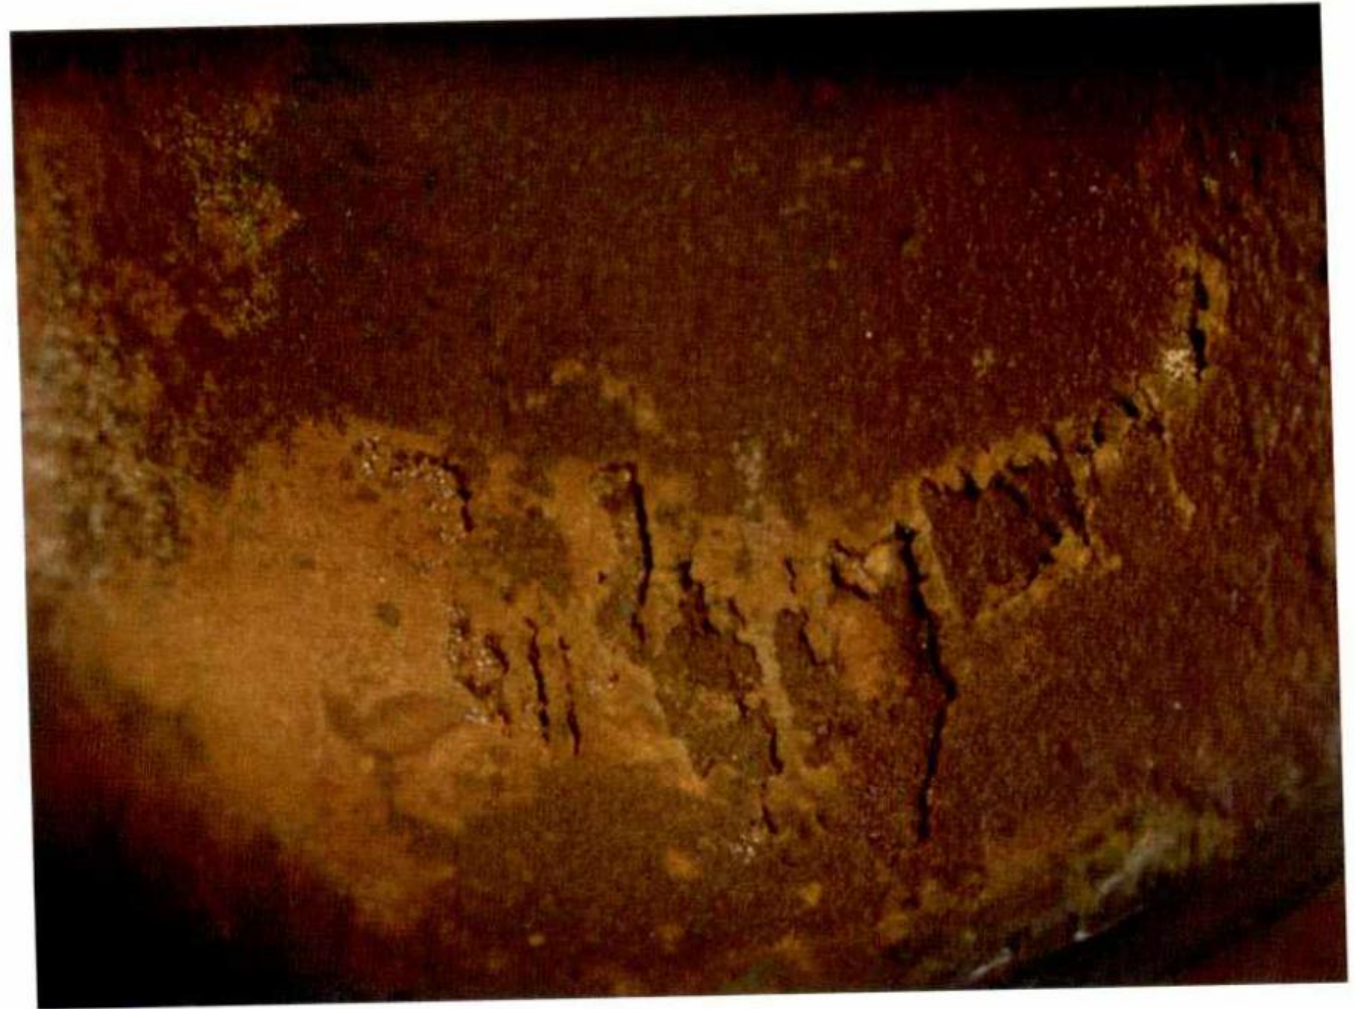
# Propane Cooler Outlet Site A

- 2011 replaced end of life piping DS of propane condenser. 3" Sch80 Nom 0.300". Hydro completed with water which wasn't completely removed. New pipe holed through in 6 days – 18-20k mpy corrosion
- 2017 – propane cooler outlet – Thickness inspection October 2016 – nozzle 0.400" – holed through with significant widespread corrosion in January 2017 – 1200 mpy corrosion

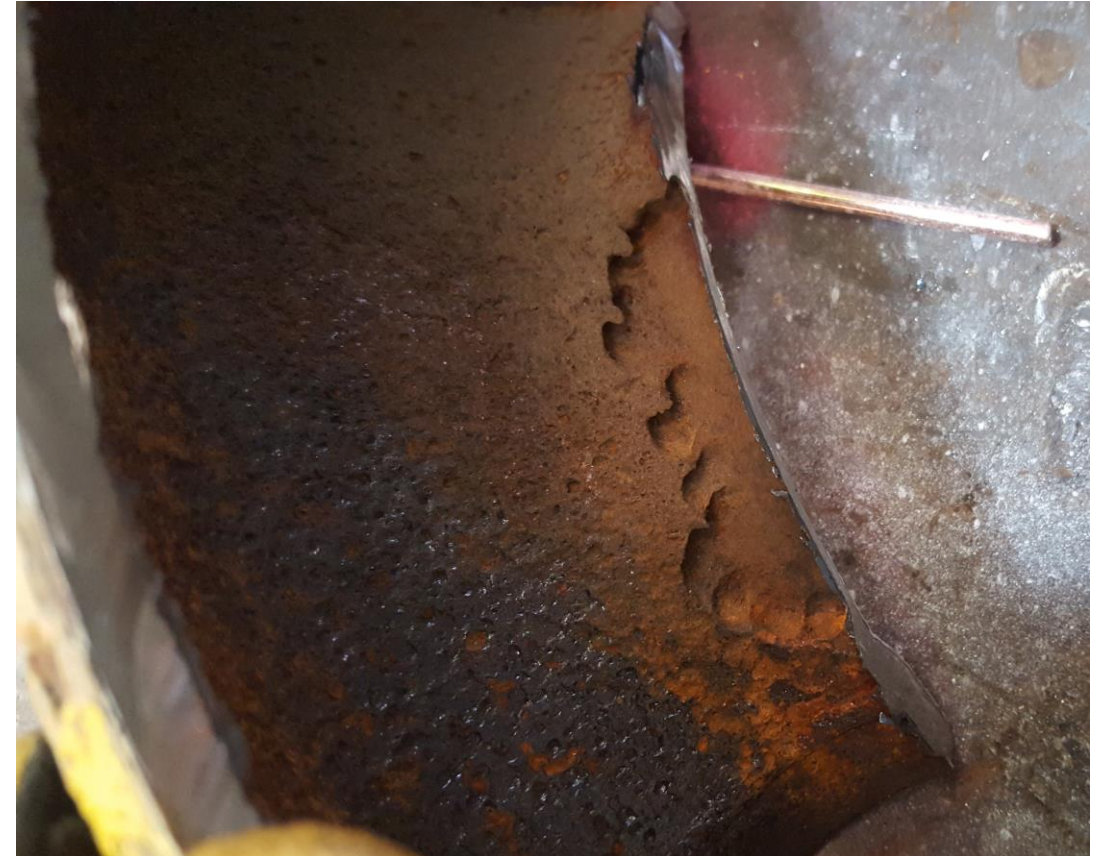
# Propane Cooler Outlet

- 4" Propane Cooler outlet nozzle
- Was replaced 2010, significant corrosion finding in 2016
- Suspected dew point at outlet of nozzle
- Intrados top side of elbow unexpected location of most accelerated corrosion
- Fabrication defect initiation?
