Ni Alloy Corrosion

Frank Sapienza

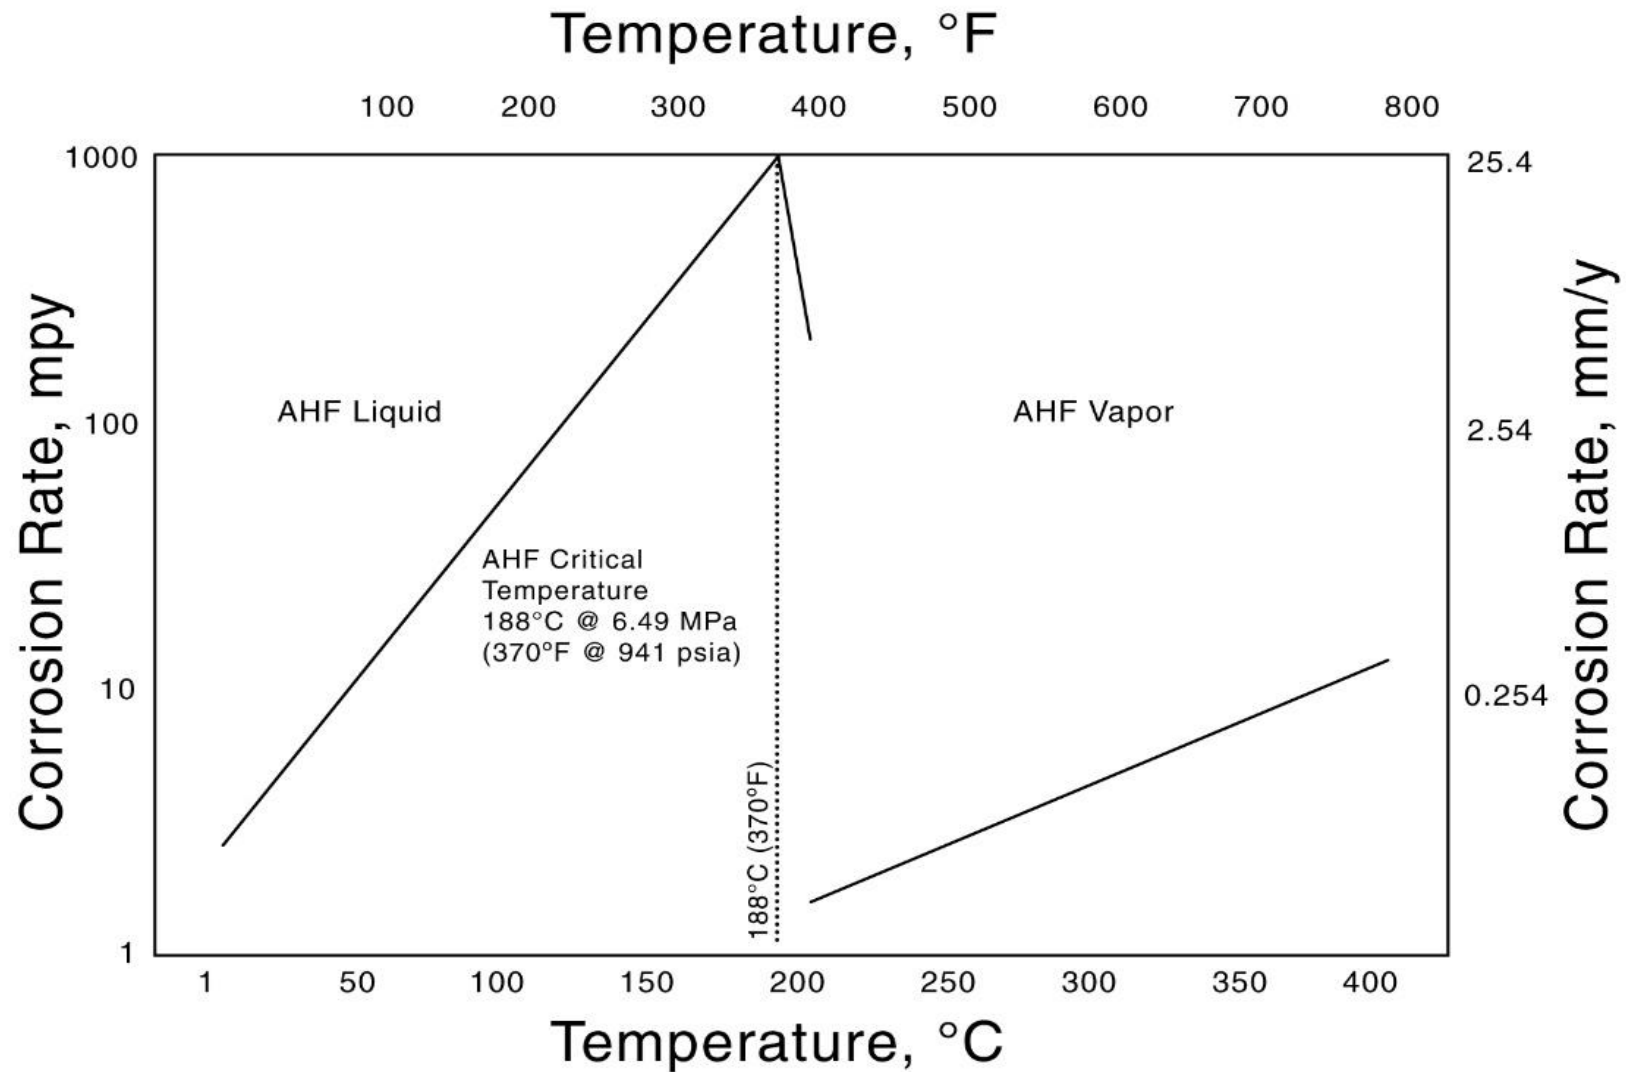
Vapor HF Corrosion

- Hot HF Vapor
 - Hot HF (with residual water only) is sent from some regeneration units. CS can tolerate this hot HF as long as it does not condense. Localized corrosion issues where mixed into settler (Phillips) or fractionation (UOP) system.

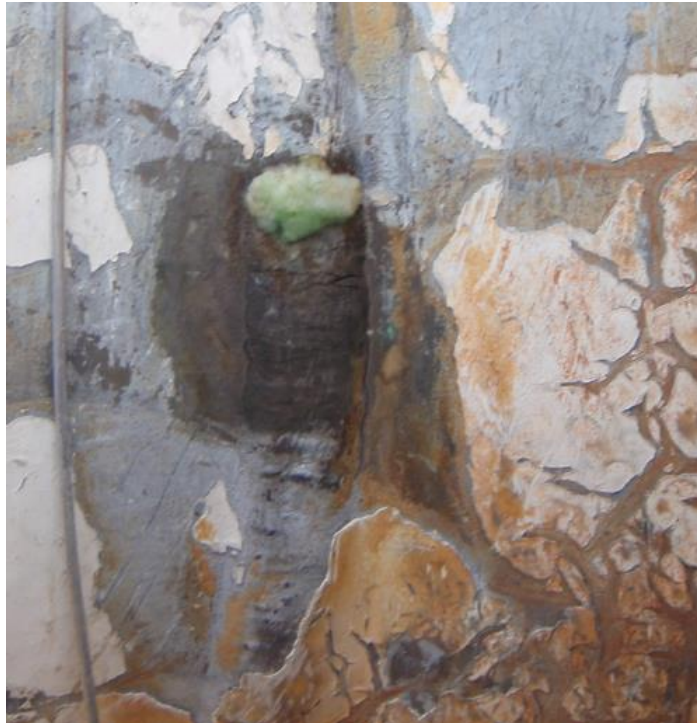
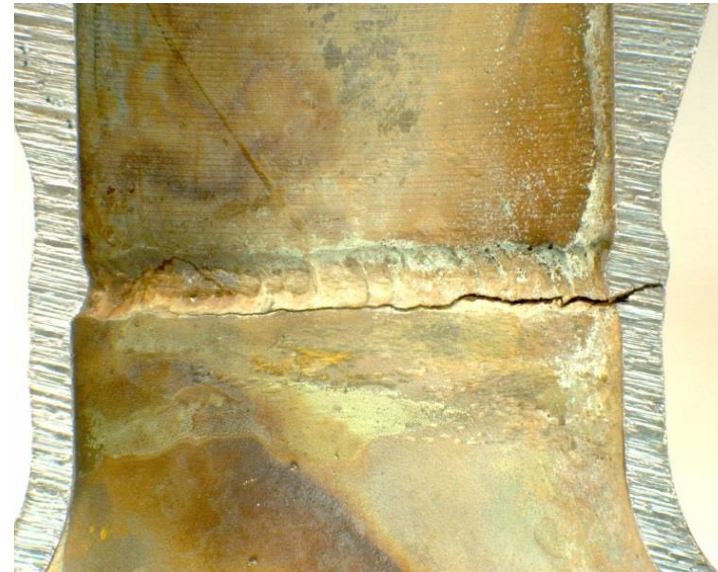
Alloy 400

- SCC potential
- Oxygen significantly increase potential of SCC
- Cold working (tube bending) and residual stress from welding are generally enough stress to initiate SCC in the presence of oxygen
- Stress relief at 1300°F may be required vs. 1175°F

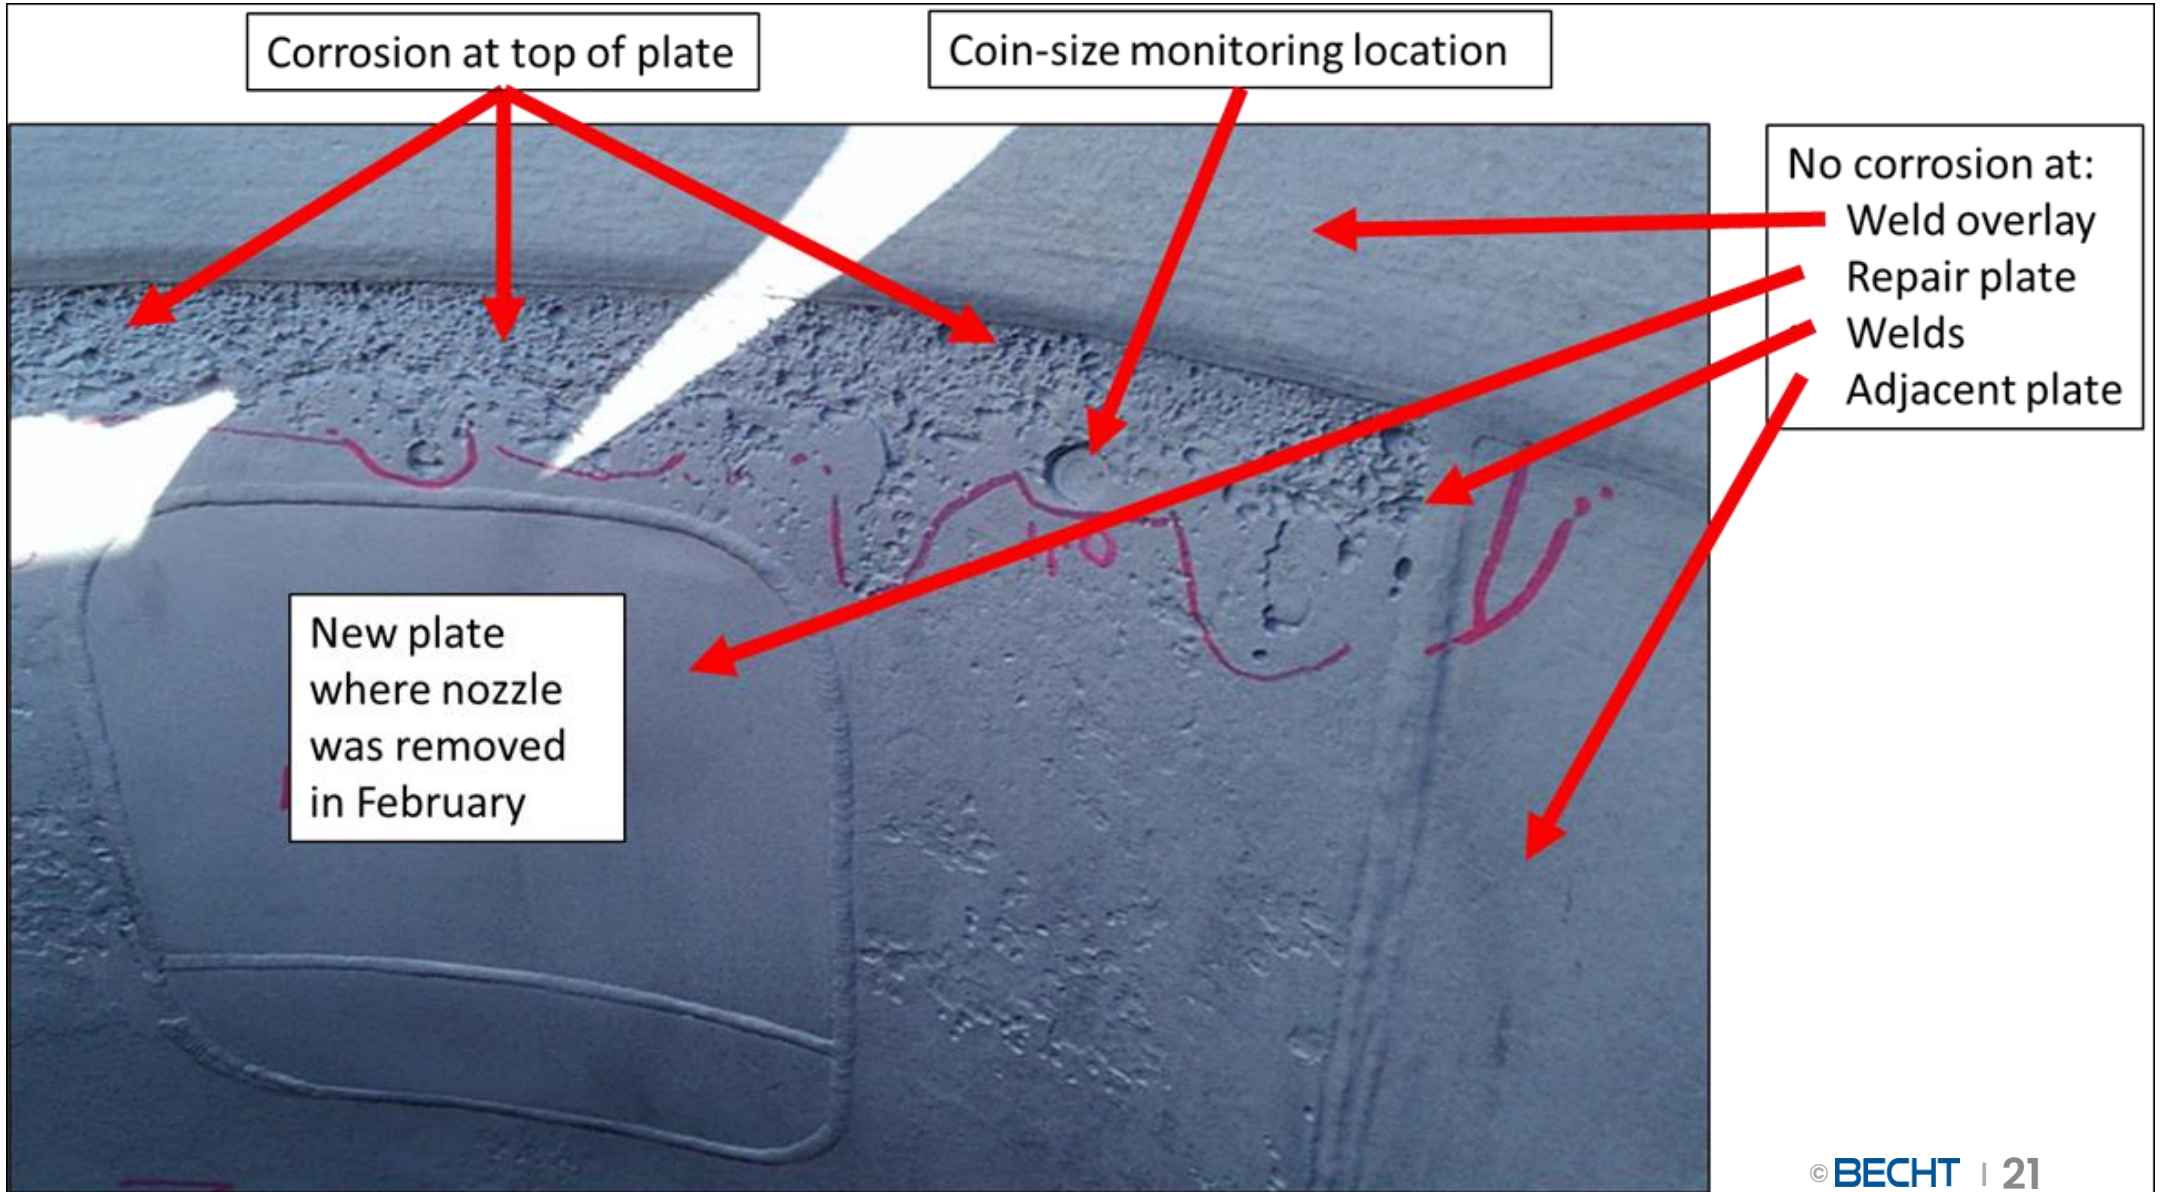
Additional Sharings

- Corrosion in rerun constructed from two Monel plates that came from different heats
- A nozzle caused liquid to condense and drain into the tower, leading to local damage due to a small phase change area under the nozzle
- One of the Monel plates in the tower was significantly less resistant to corrosion than the other plate or the welds and overlay in the tower

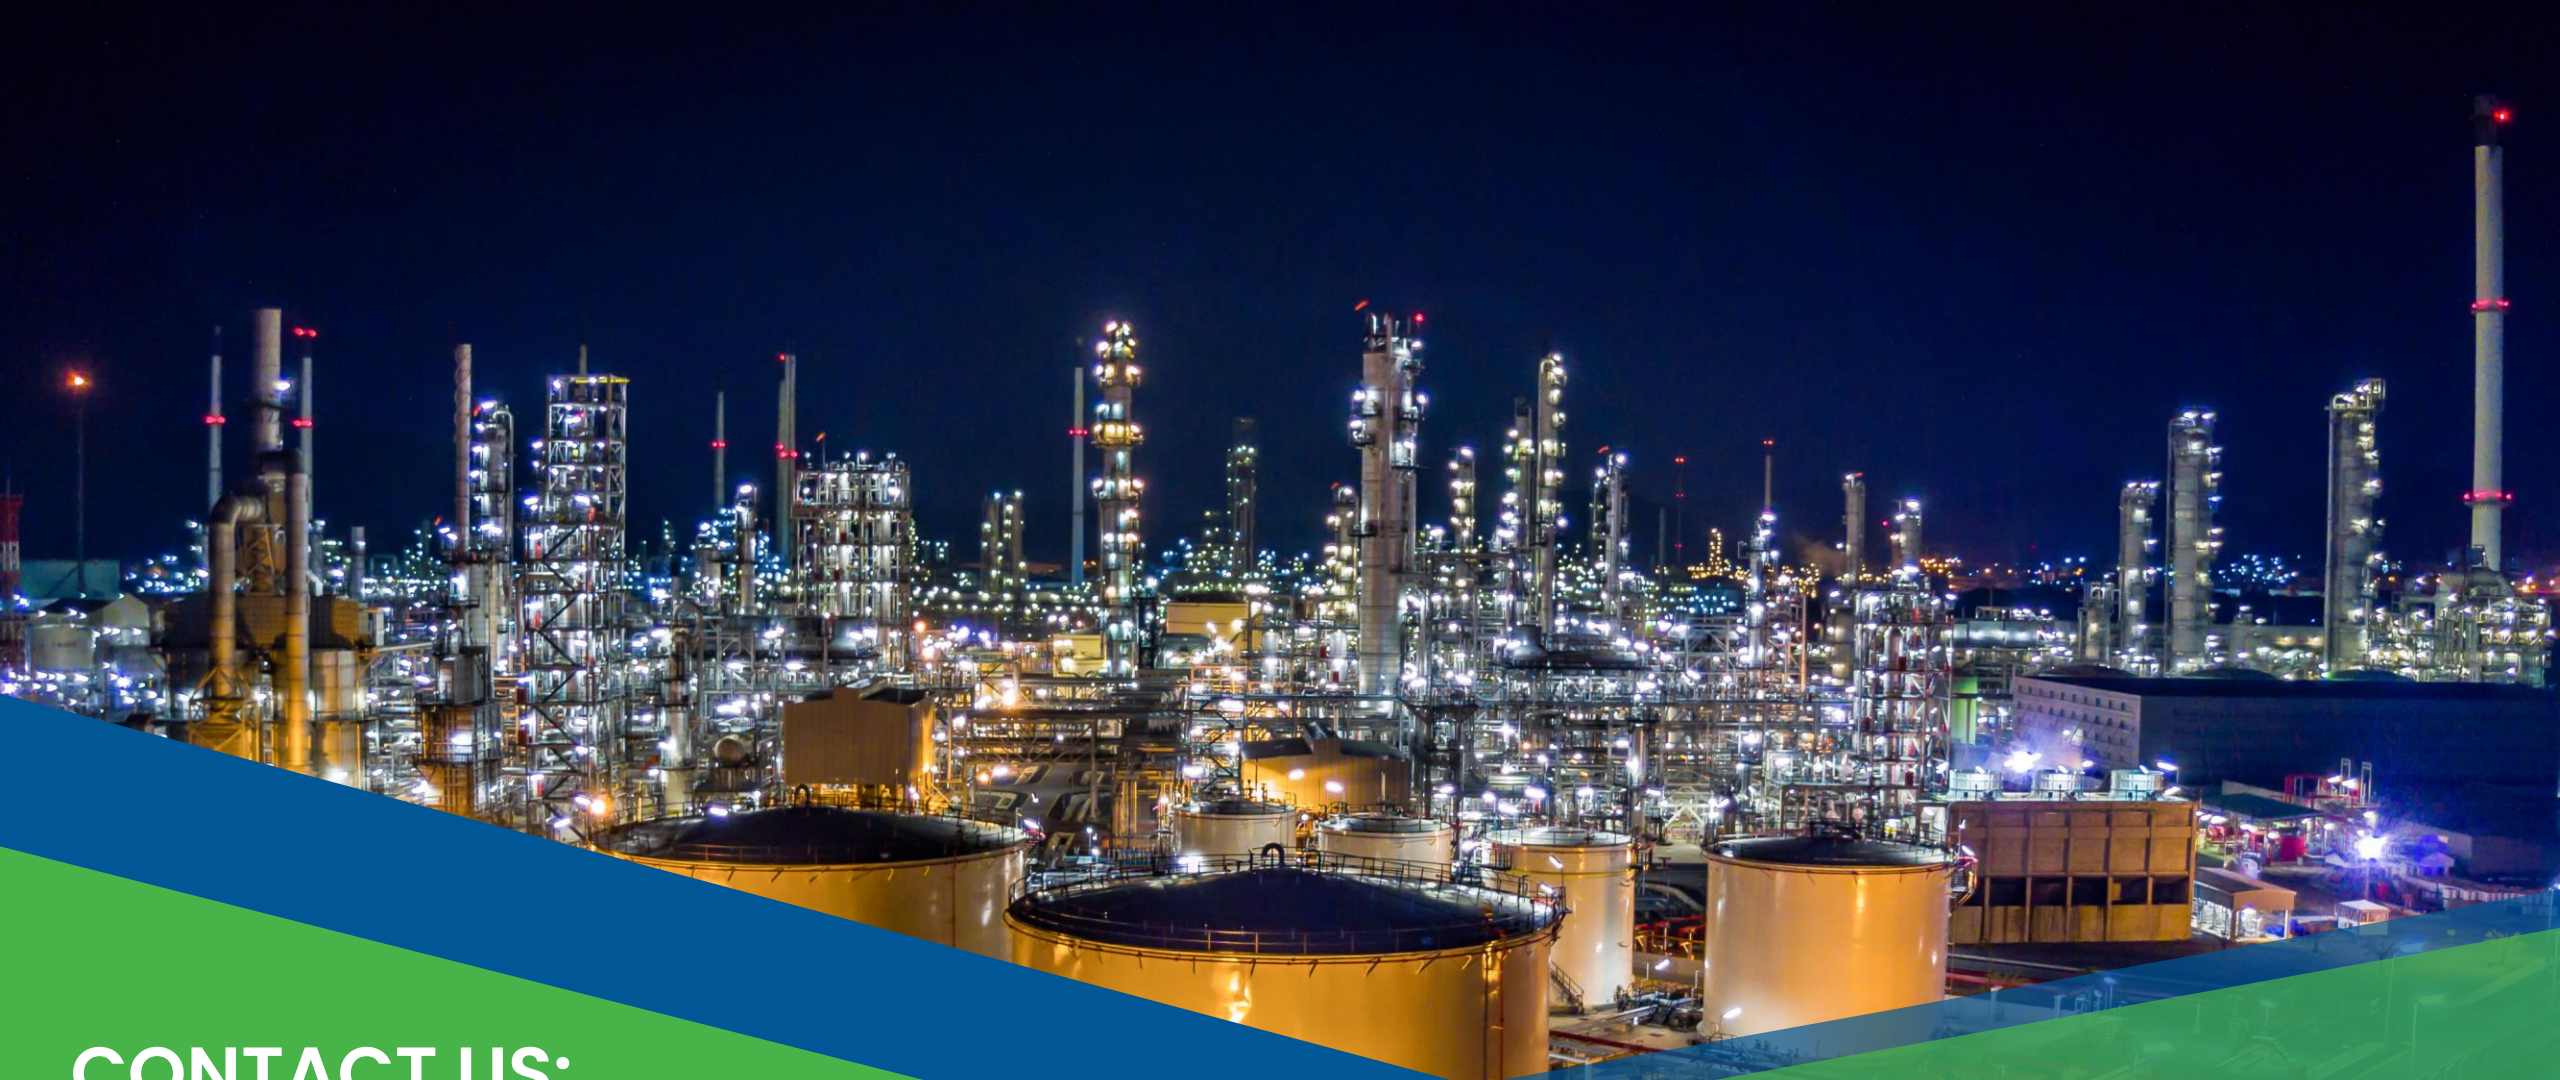
Additional Sharings

- Cracked Hastelloy C PSV bellows in Isostripper overhead receiver relief
- Alloy C2000 is insufficient in aggressive tower operation.
 - significant corrosion of C2000 internals and C2000 overlay
 - coupon testing showed no significant difference
- C276 level instrument magnetic floats often used in this zone have no reported issues to date (?)
