# Cracking the code: FCC turnaround lifecycle best practices – Part 2

The common FCC equipment and recommended engineering practices are reviewed, followed by unit start-up and turnaround report generation

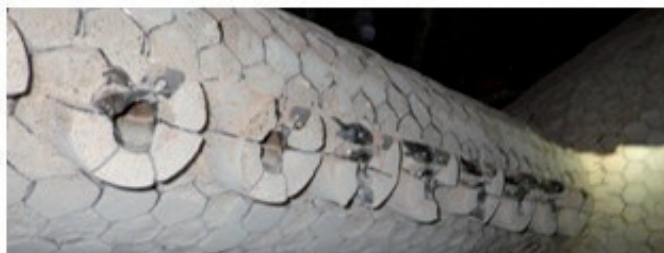
**Figure 1** Air distributor nozzle erosion

The regenerator air distributor nozzles should be inspected for erosion and plugging (see **Figure 1**). A good practice is to have an air grid pattern drawing and note damaged or plugged nozzles. The turnaround group may want engineering to note nozzles requiring repair with spray paint as well as a drawing.

Nozzles may need to be plugged if they are severely damaged or causing impingement. A repair plan should be developed between the turnaround group, process

engineering/subject matter expert (SME), and operations. The final repair should be documented on the air grid nozzle and included in the turnaround report. If nozzles are plugged, estimates on the air loss should be calculated.

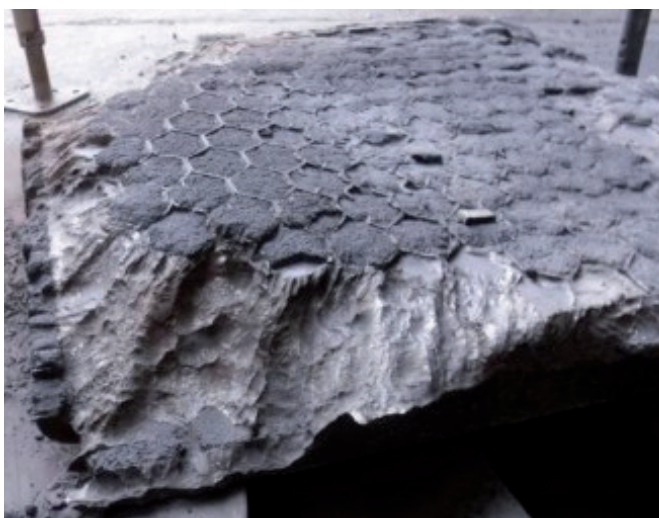
**Figure 2** Severely eroded slide valve gate

Unit monitoring of slide valves during operations between turnarounds can be used to help indicate slide gate wear

(see **Figure 2**), especially severe wear on the slide valve gate. Excessive wear around the stem and/or guides may indicate issues with the packing purge or excessive use of the guide purge. Erosion issues should be reviewed with the slide valve vendor to determine whether the valve can be refurbished or should be replaced. Sticking issues during the run may also indicate issues with packing purge, guide clearance, or wear.

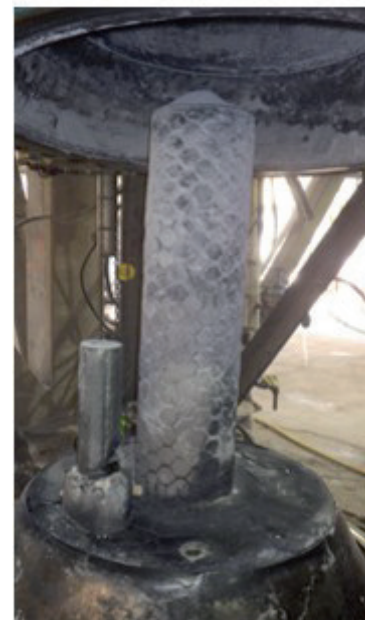
**Figure 3** Riser wye – steam chest

Inspect all taps and ensure aeration and pressure taps are all clear. All ROs should be inspected (pulled, verify opening, replace as needed). Carefully inspect the wye/l bend area for unusual wear (see **Figure 3**). Identify areas of excessive wear for repair and upgrades in future turnarounds. Note areas with significant refractory repair and assess if replacement is justified.

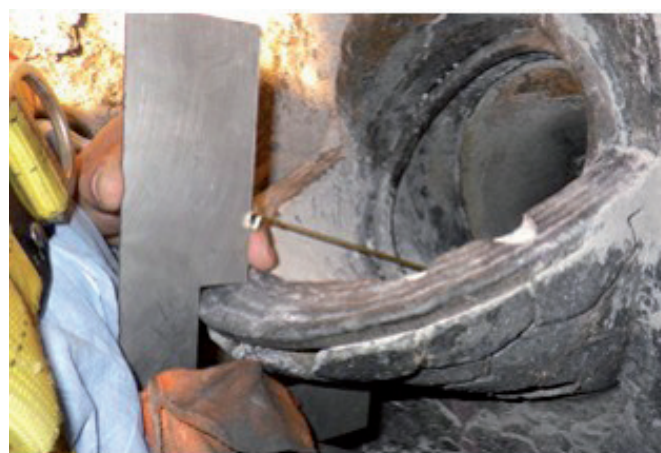
**Figure 4** Feed nozzle measurement prior to installation

If there are issues, recommend reviewing the feed nozzle preparation prior to nozzle insertion (see **Figure 4**). Damage to the insert may also need to be addressed. Feed nozzles should be inspected in the riser prior to removal for plugging, coke around or near the nozzles and refractory

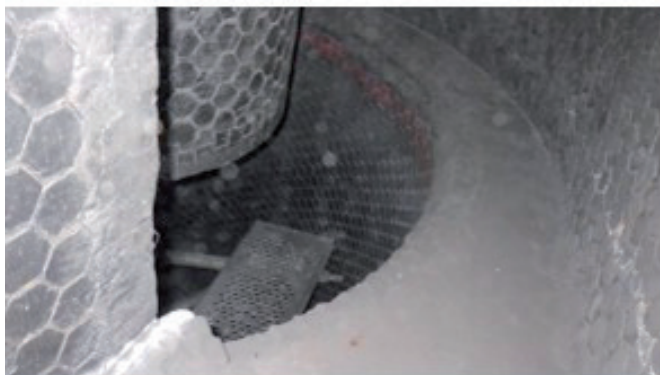
**Figure 5** Primary cyclone inlet refractory damage

The condition of steam distributors, such as dome steam rings, cyclone steam, primary cyclone pre stripping steam (see **Figure 5**), cyclone bathtub grid and other internal piping, should be inspected and damage noted. Damage should be investigated for possible upgrades, particularly if similar damage was noted in the prior turnaround.

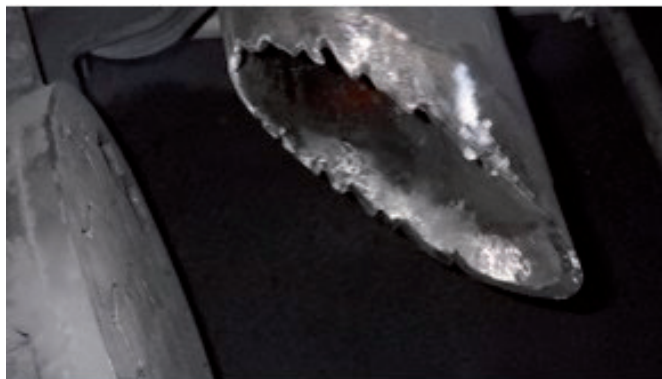
**Figure 6** Secondary cyclone dipleg erosion

Reactor rise termination and cyclones should be inspected for unusual wear patterns, wear to hex mesh, coke build-up in cyclones, and damage. Ensure inspection of unlined portions of the dipleg for wear (inspection should also check dipleg thickness). Inspect for dipleg hole-through, particularly in transition areas from the lined to unlined sections of the dipleg. Today, diplegs are often inspected with cameras. Coke around the back side of the secondary cyclone is common and should be removed if excessive to prevent spalling of the coke, potentially plugging the secondary dipleg (see **Figure 6**).

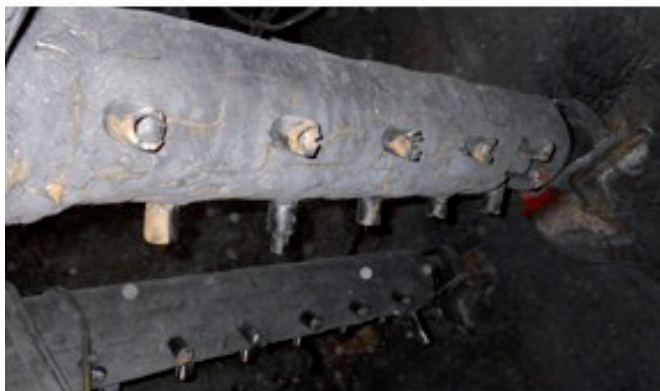
**Figure 7** Steam distributor nozzle erosion

The reactor stripper should uniformly distribute catalyst and steam over the stripper diameter. Damage and plugging to the shed trays, disc/donuts or stripper packing should be noted and addressed in the turnaround. Plugging distribution holes in the tray decks should be noted and cleared. Damage to the stripping steam distributor nozzles or steam distribution should be noted and repaired (see **Figure 7**).

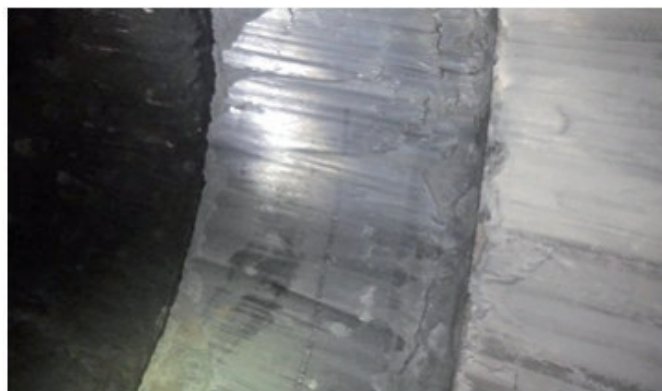
**Figure 8** Reactor overhead isolation valve coke build-up

The reactor overhead line can be subject to erosion and coke build-up (see **Figure 8**). As part of the inspection, note any coke build-up in the reactor overhead line. Note any damage to refractory lining, particularly around elbows. Significant coke build-up should be removed. Sites can consider using high-pressure water to dislodge coke. Coke in the fractionator inlet should also be noted and removed (see **Figure 9**).

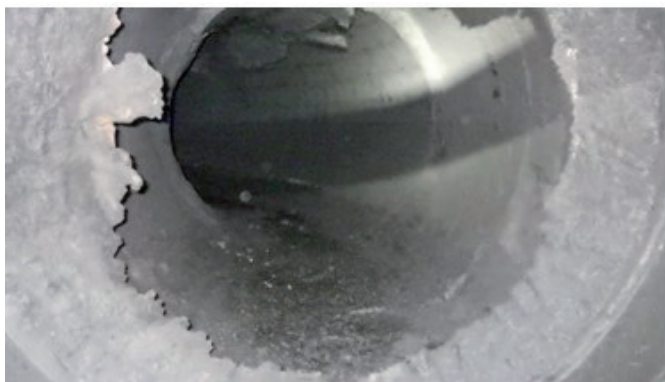
**Figure 9** Fractionator inlet coke build-up
